DRYZONE[®]

DAMP-PROOFING CREAM

The World's Most Rigorously Tested Rising Damp Treatment

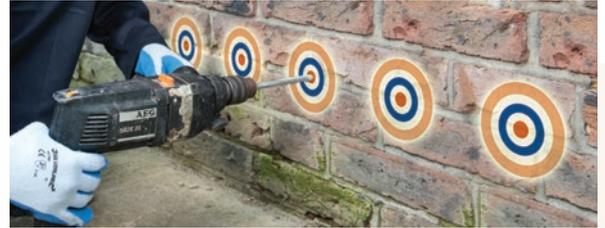
1. Drilling

First create a series of horizontal drill holes along the mortar course. Typically these are 12 mm holes at 120 mm intervals – refer to the **Dryzone®** application instructions for details for particular wall thicknesses.

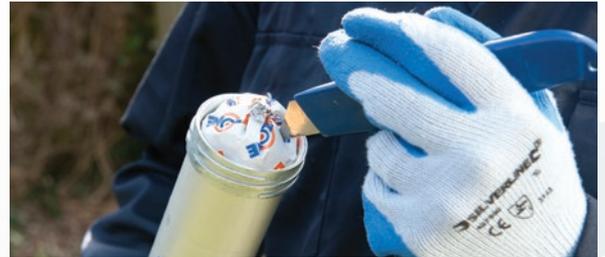
2. Preparation

Insert a **Dryzone®** cartridge into the applicator gun, ensuring the pressure piston is fully extended. Cut into the end of the cartridge so that cream will be able to flow freely. Screw the nozzle cap back onto the gun.

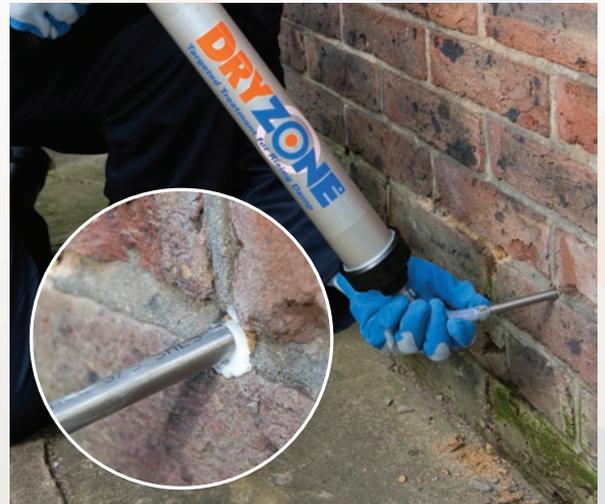
3. Injection

Fully insert the nozzle into the first drilled hole, and then inject **Dryzone®** cream while withdrawing the nozzle at a steady rate. Stop injecting just before removing the nozzle from the wall. Repeat for remaining holes.

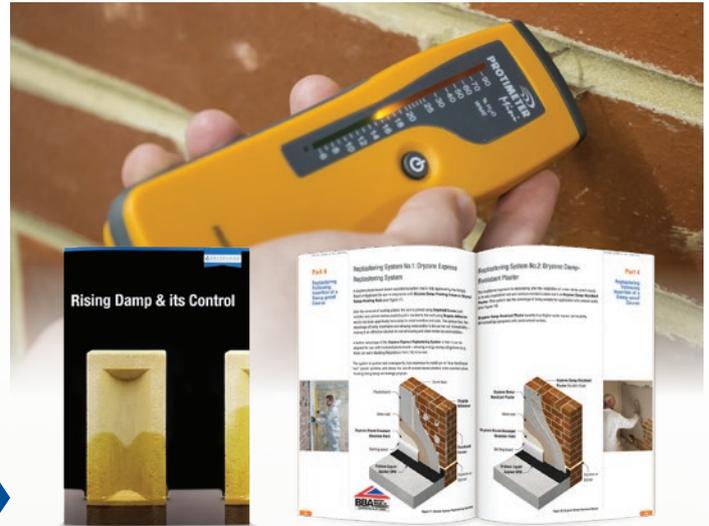
The diagram below illustrates a typical traditional replastering solution. Depending on the situation and time constraints, Safeguard recommend three replastering methods:

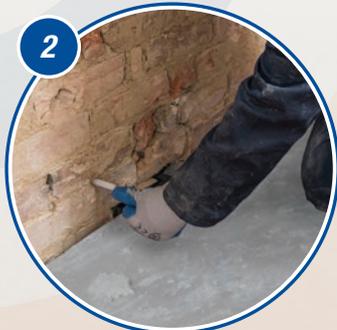
Install Damp-Proof Course
Install the new damp-proof course using either **Dryzone® Damp-Proofing Cream** or **Dryrod® Damp-Proofing Rods**.

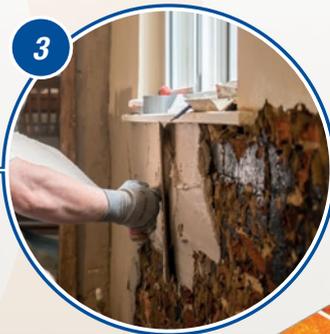
Apply Scratch Coat
Apply a rough coat of at least 5 mm thickness. This will act as an anchoring layer.

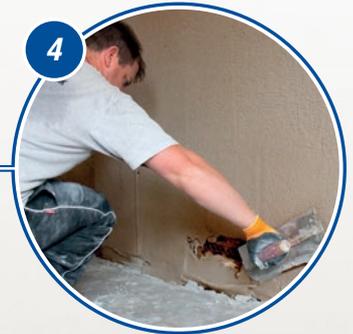
Apply the Plaster Coat
Once the rough coat has become firm, apply the plaster again with a thickness of at least 15 – 20 mm.

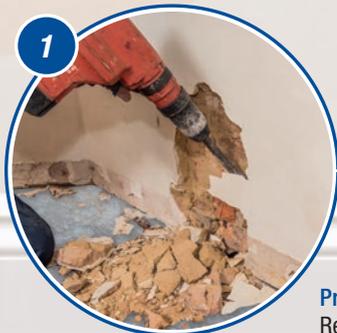
Prepare the Wall
Remove damp/salt contaminated plaster.

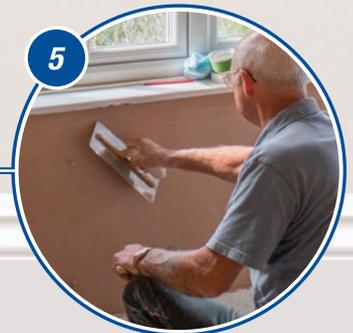
Finishing Coat
Apply the final skim coat using a suitable skim plaster.
